# Rock Island Arsenal Laboratory

EVALUATION OF PHOSPHATE FINISHES ON STEEL AS UNDERCOATS  
FOR ARMY PAINT SYSTEMS

Report No. 83-2823

Date 26 November 1963

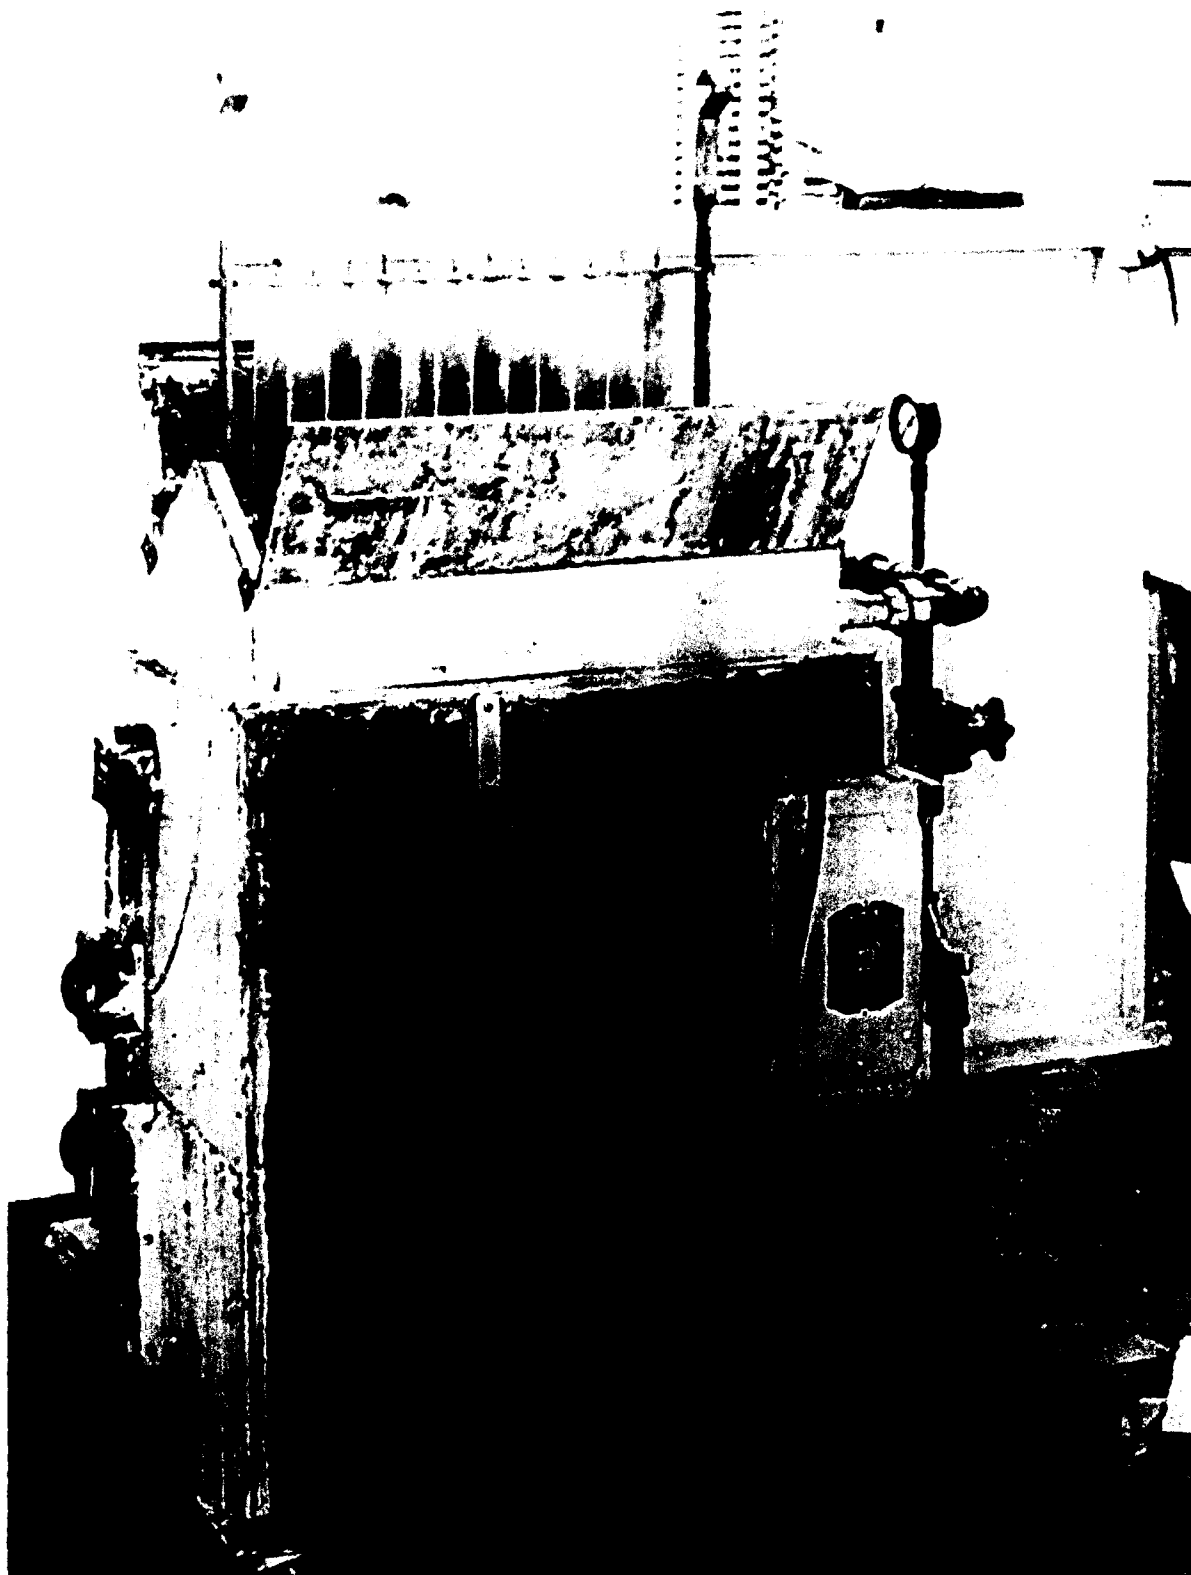
RIA Neg. No. 4389

Model 50-F-75G spray phosphating cabinet (Figure 1), manufactured by the Pioneer Pump & Manufacturing Company of Detroit, Michigan, was used for those coatings which were to be applied by spray. This cabinet was equipped with thermostatic controls. In the instances where hand spraying was indicated a Model 19 spray gun, which was manufactured by the Binks Manufacturing Company of Chicago, Illinois, was used.

SPRAY PHOSPHATING CABINET

Panels were racked vertically in the specially designed holder (Figure 1). Once the panels were racked, they remained

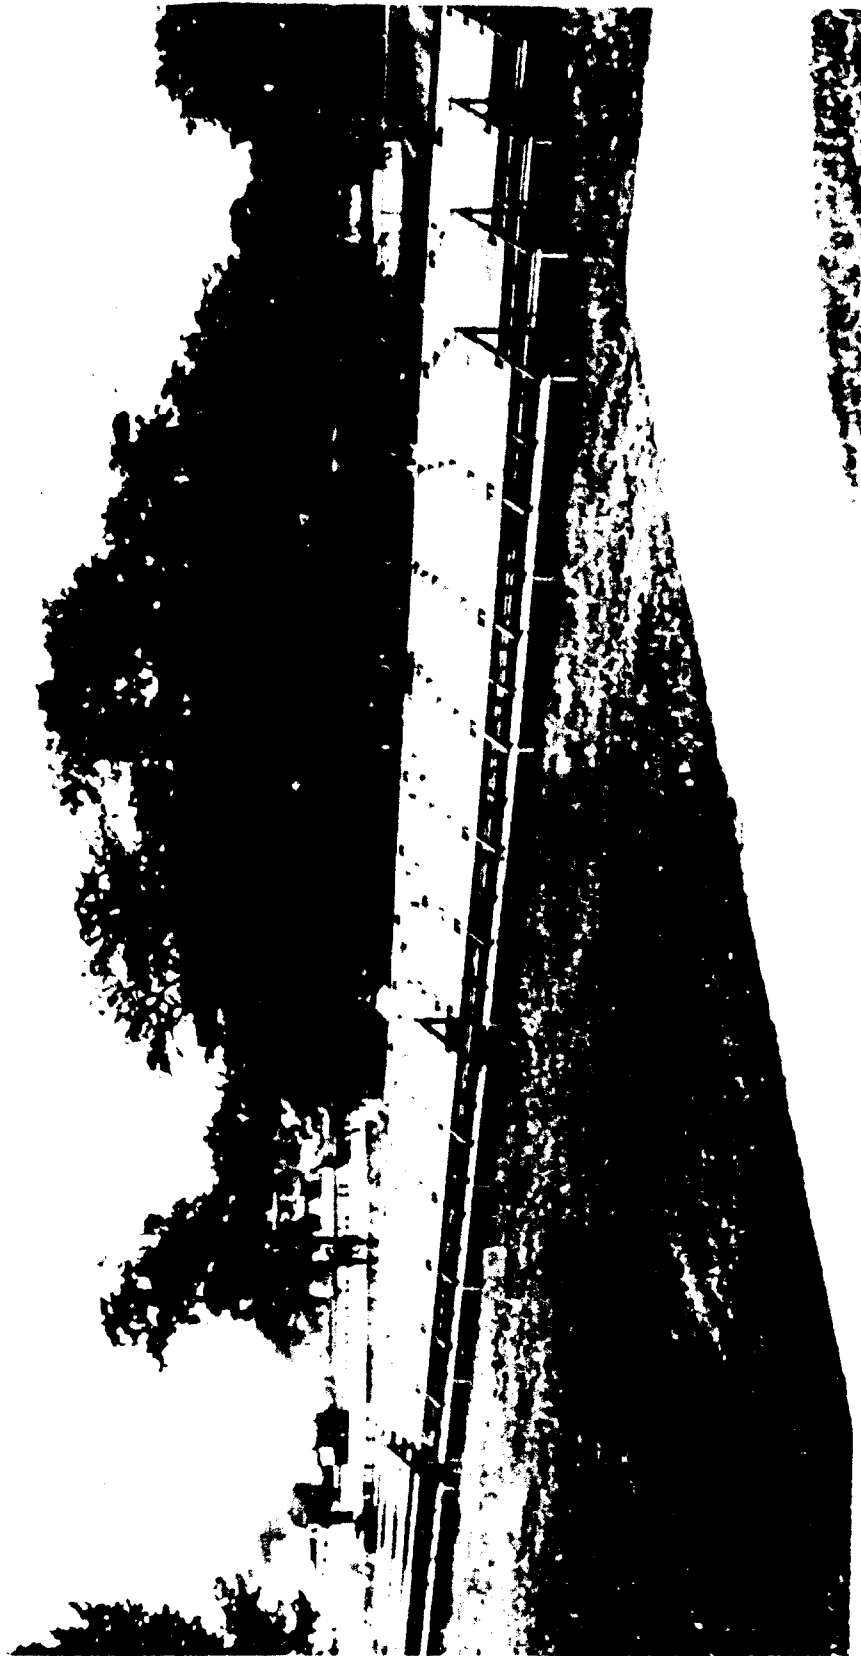
Figure 3

After the phosphating products and the various paints and paint systems had been applied, the panels were allowed to air-dry for 72 to 96 hours. The panels were then edged with an aluminum pigmented tung oil modified phenolic resin varnish to minimize edge corrosion. The panels were then scored with a sharp scribing tool which cut a line parallel to the left side, one inch from the edge and running to points 2 inches from the top and 1-1/2 inches from the bottom. This score line was cut through the paint and phosphate coat into the basis metal. Six panels from each of the 9 paint systems were placed in specially constructed racks for outdoor exposure (Figures 3, 4 and 5).

OUTDOOR EXPOSURE AREA

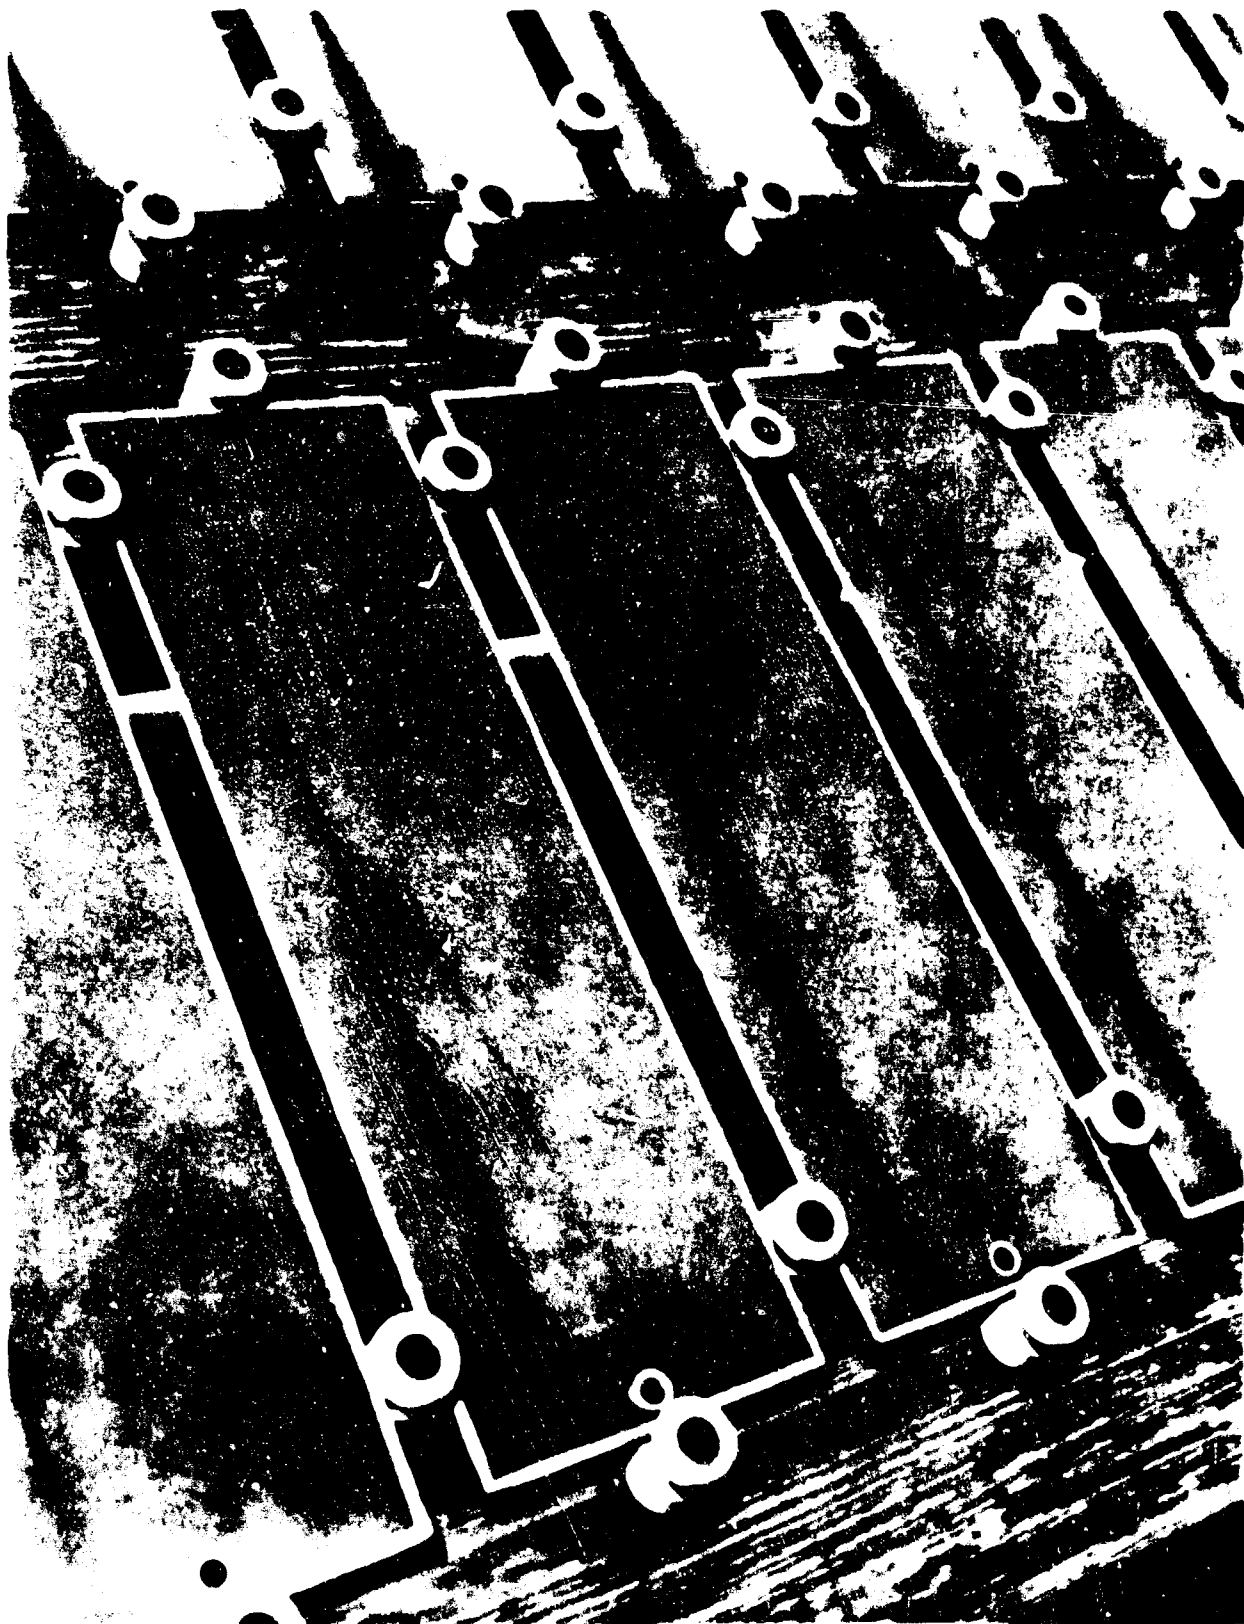
For one year the panels were held in position by wooden crossbars. This was revised, using porcelain insulators, as shown in Figures 4 and 5.

CLOSE-UP OF EXPOSURE RACK SET-UP
